# Smoke and Dye Testing Summary

## High Level Sewershed

| Run Summary | | | | | | | |
|---|---|---|---|---|---|---|---|
| D1028-163 | Dye | 4/27/2009 | ADS/TM | S15GG1032MH | Dry | NA | |
| Address | 2601 Park Heights Terrace | | Location | Curb | Status | Public | Source Catch Basin |

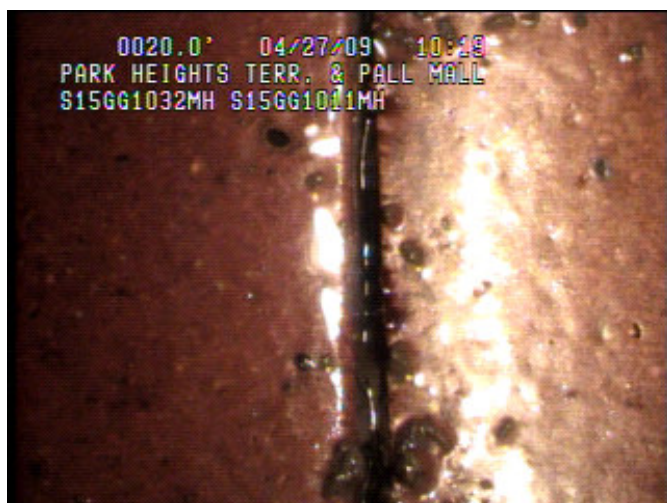
**Picture** \D1028-163-OB01-P01.jpg

**Comments** Dye observed 20.0 ft. downstream of S15GG1032MH. Infiltration runner at joint at 10 oclock.

**Comments** 20.0 ft. downstream of S15GG1032MH along S15GG1032G1.

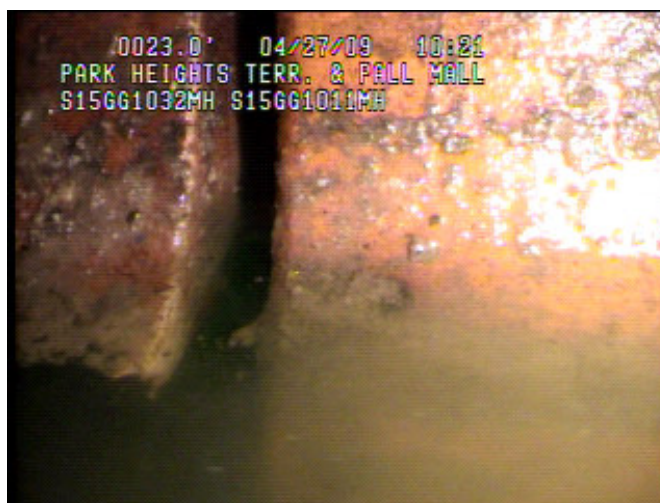
**Picture** \D1028-163-OB02-P01.jpg

**Comments** Dye observed 23.0 ft. downstream of S15GG1032MH. Infiltration runner at joint at 5 oclock.

**Comments** 23.0 ft. downstream of S15GG1032MH along S15GG1032G1.

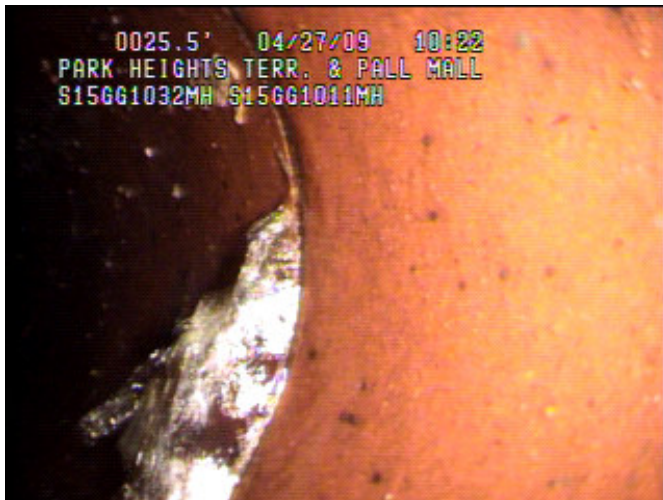
**Picture** \D1028-163-OB03-P01.jpg

**Comments** 25.5 ft. downstream of S15GG1032MH along S15GG1032G1.

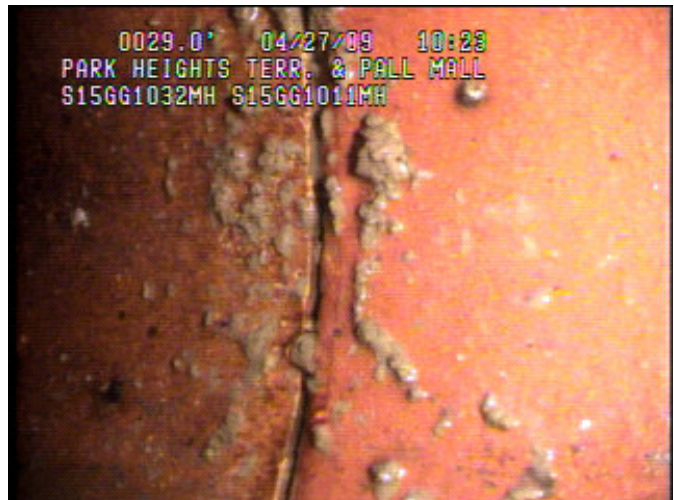
**Picture** \D1028-163-OB04-P01.jpg

**Comments** 29.0 ft. downstream of S15GG1032MH along S15GG1032G1.

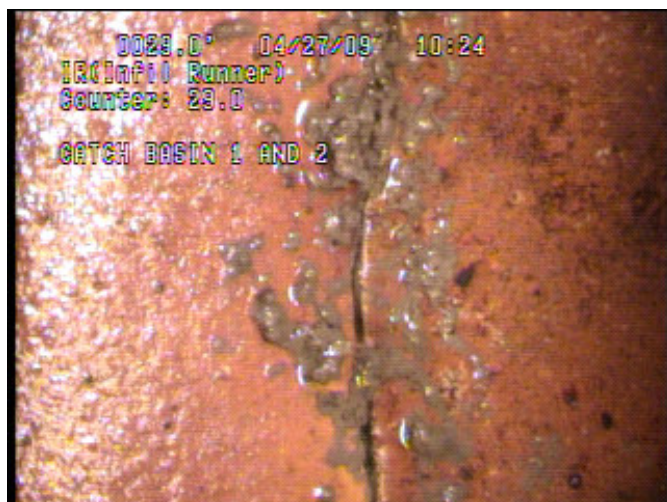
**Picture** \D1028-163-OB05-P01.jpg

**Comments** Dye observed 29.0 ft. downstream of S15GG1032MH. Infiltration runner at joint at 8 oclock.

**Comments** 29.0 ft. downstream of S15GG1032MH along S15GG1032G1.

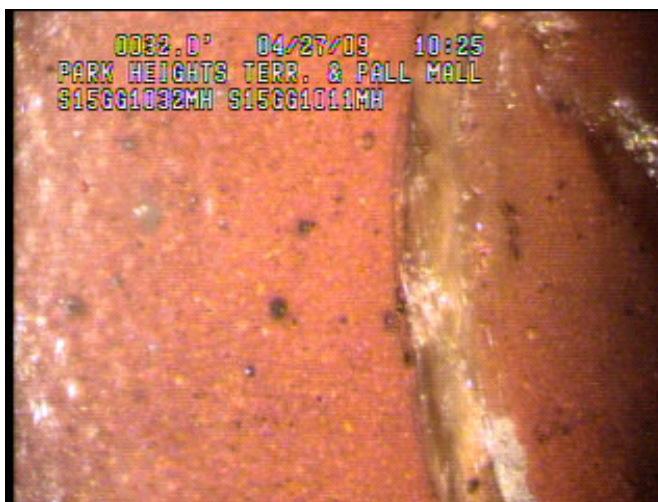
**Picture** \D1028-163-OB06-P01.jpg

**Comments** Dye observed 32.0 ft. downstream of S15GG1032MH. Infiltration gusher at joint at 10 oclock.

**Comments** 32.0 ft. downstream of S15GG1032MH along S15GG1032G1.

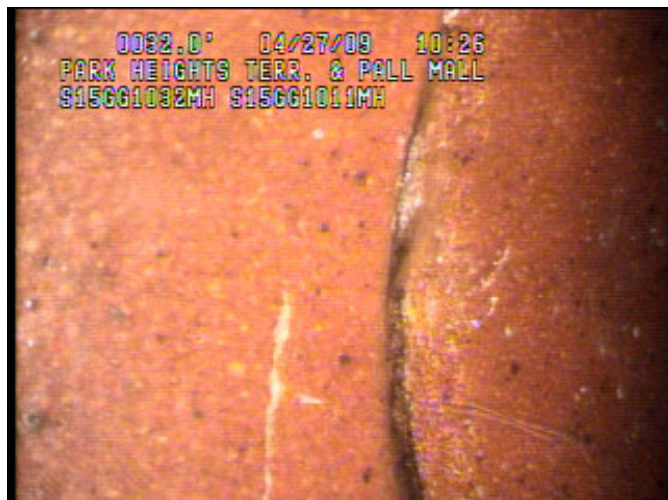
**Picture** \D1028-163-OB07-P01.jpg

**Comments** 32.0 ft. downstream of S15GG1032MH along S15GG1032G1.

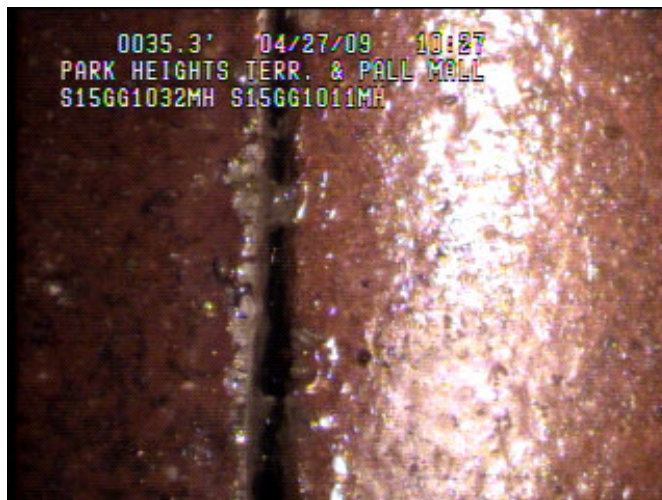
**Picture** \D1028-163-OB08-P01.jpg

**Comments** 35.3 ft. downstream of S15GG1032MH along S15GG1032G1.

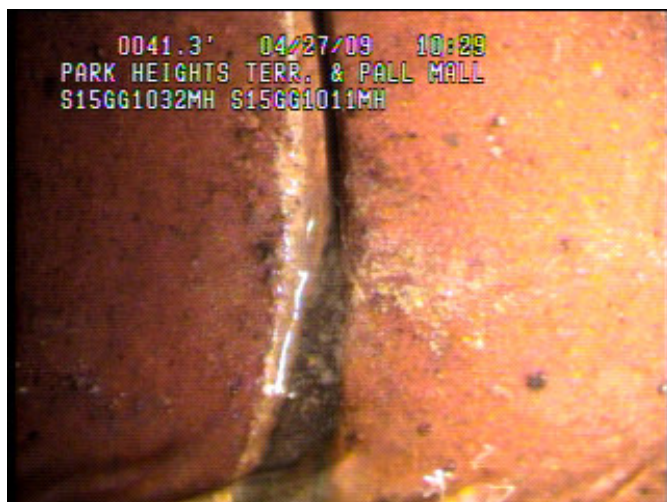
**Picture** \D1028-163-OB09-P01.jpg

**Comments** 41.3 ft. downstream of S15GG1032MH along S15GG1032G1.

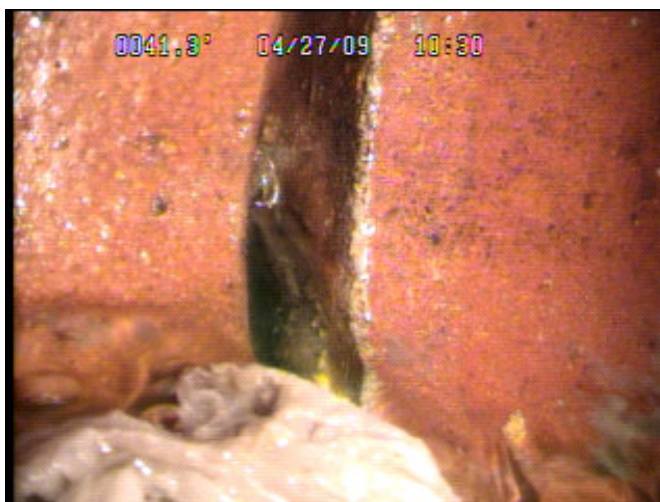
**Picture** \D1028-163-OB10-P01.jpg

**Comments** 41.3 ft. downstream of S15GG1032MH along S15GG1032G1.

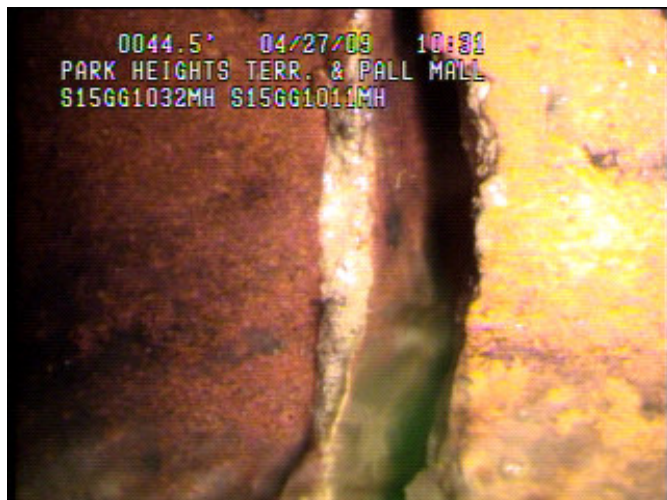
**Picture** \D1028-163-OB11-P01.jpg

**Comments** Dye observed 44.5 ft. downstream of S15GG1032MH. Infiltration runner at joint at 5 o'clock.

**Comments** 44.5 ft. downstream of S15GG1032MH along S15GG1032G1.
